Expert Report

Wadsworth v. Jetson et al

Derek King, M.S., P.E.

Berkeley Engineering and Research, Inc. July 12, 2024

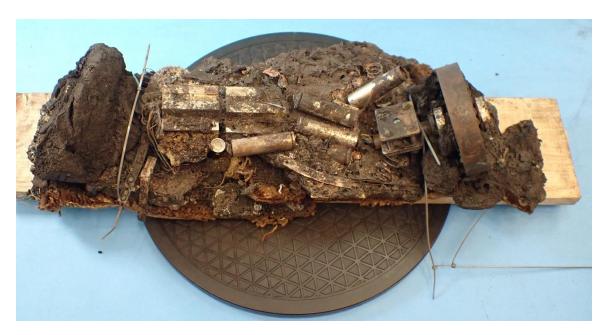
Figure 1: The remnants of the subject Jetson hoverboard.

Detailed examination of the subject board shows that two out of ten cells exploded while the other eight cells show heat damage. Exploding cells are consistent with an internal short, thermal runaway, and vaporization and ignition of the liquid electrolyte.

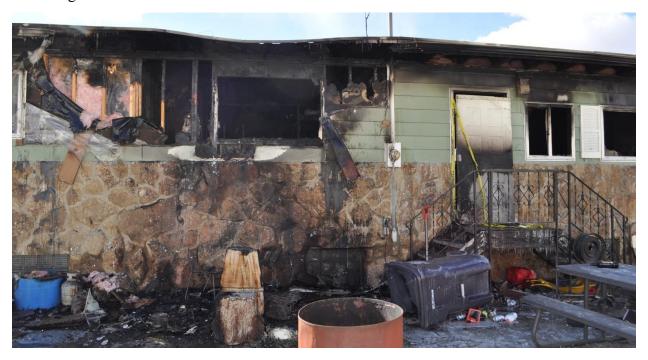
Figure 2: The bedroom window where the subject hoverboard was found.

- An exterior fire would have to rise along the wall, enter through the eves, and then burn down to eventually reach the subject board. The exterior wall should therefore be exposed to the fire for the longest duration.
- The exterior of the house at and around the window area is substantially less fire damaged than the interior. The exterior wall studs are largely intact. This suggests a shorter and less intense exposure to fire on the outer wall compared to the interior.
- Detective Sheaman observed an interior V-pattern which included studs which were nearly completely consumed by the fire.

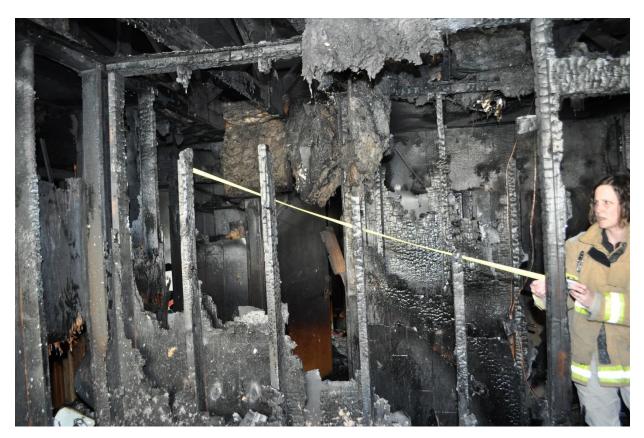
Figure 3: Interior wood studs in the bedroom/hallway wall show preferential consumption from fire pointing towards the subject board location ("V-pattern").

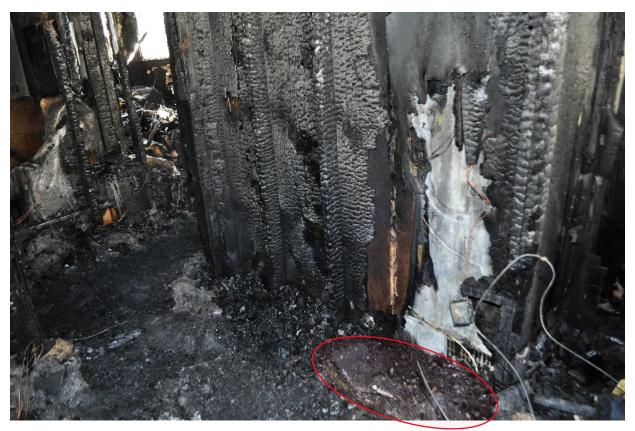
Figure 4: The general location of where the wall V-pattern points. The wall above the subject board (circled) is completely burned away.

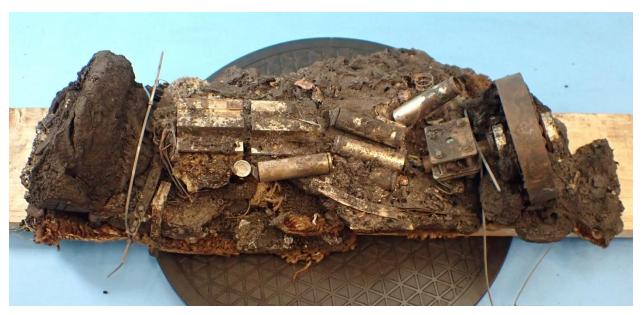
Figure 5: The subject board as-received by BEAR. The wood plank appears to be added for physical support of the loose evidence.

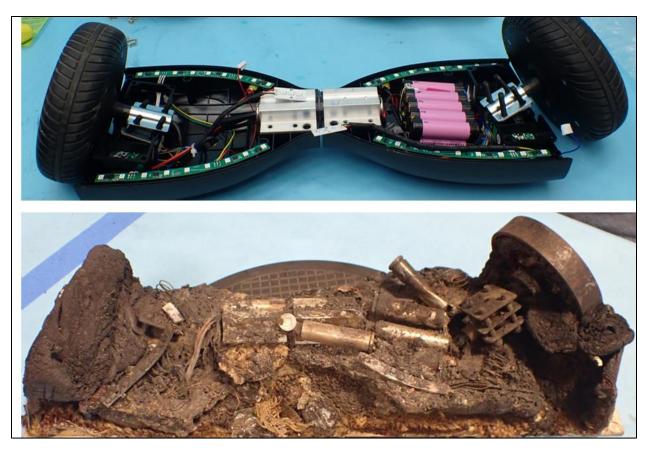
Figure 6: An exemplar board disassembled and oriented approximately the same as the evidence.

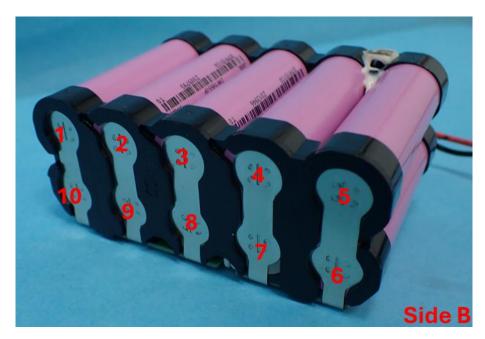
Figure 8: The other side of the exemplar battery pack with cells numbered for positional reference.

All 10 cells were collected and inspected. Referring to the cell numbering in the exemplar pack, subject cells 4 and 10 have ruptured and expelled their contents, while the

The difference in cell condition is consistent with cells 4 and 10 experiencing an internal short with thermal runaway and the other cells being damaged due to external heat. As shown in **Figure 7** above, cells 4 and 10 are diagonally opposite of each other within the battery pack – cell 4 is on the top and cell 10 is on the bottom. In addition to the rupture condition, the difference in the ruptured cell locations makes it unlikely that external heat would cause corresponding selective damage.
